NAVAL AIR ENGINEERING CENTER
PHILADELPHIA, PA. 19112

AERONAUTICAL MATERIALS LABORATORY

REPORT NO. NAEC-AML-2529

CORROSION RESISTANCE AND DURABILITY OF FASTENERS
IN AIRCRAFT STRUCTURES

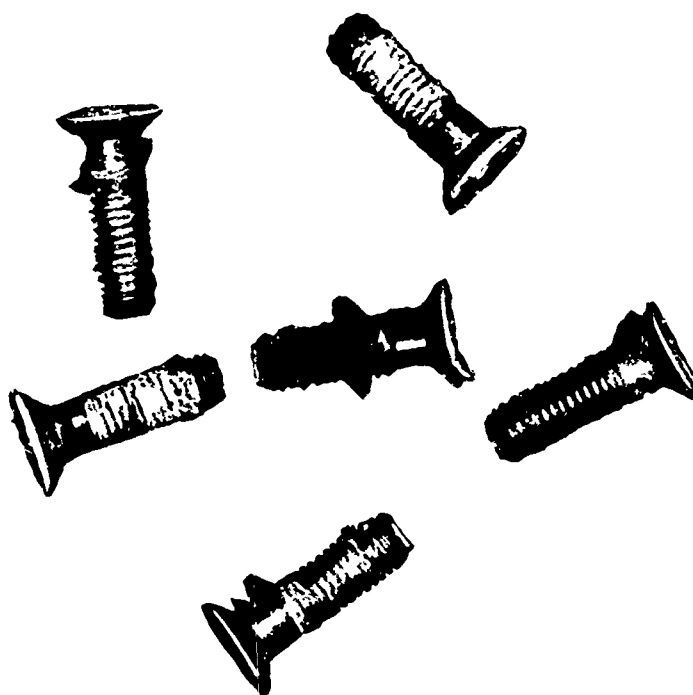
PLATE 12

POLYMERIC COATED FASTENERS AFTER SPECIMEN DISASSEMBLY

4. The polymeric coating, deposited on the fasteners in three thicknesses, was partially stripped when the fasteners were torqued. The poor adhesion of the coating to the steel fasteners is illustrated in Plate 12. Despite this, corrosion was generally reduced in countersinks with the polymeric coated fasteners, probably because the coating did provide some insulation between the fastener and the aluminum alloy.

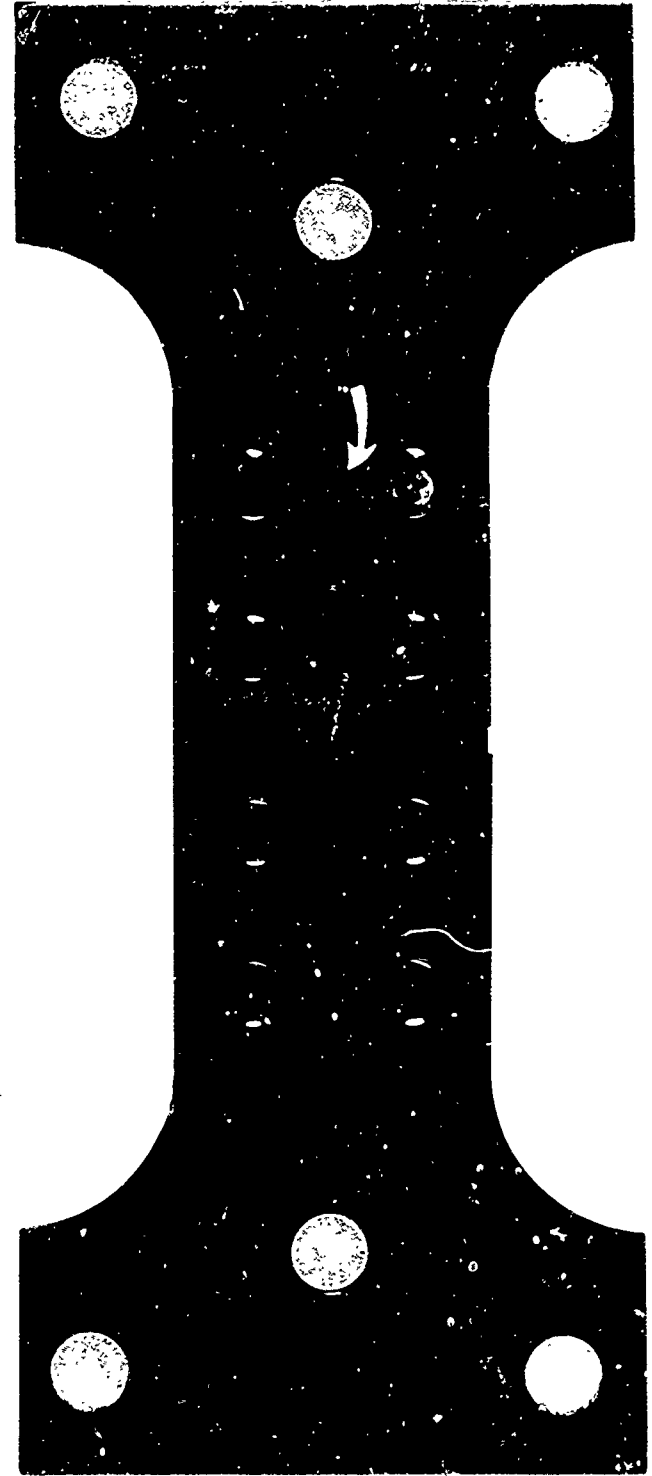
Sealant Specimen

Bare Specimen

TYPICAL FATIGUE FAILURES

The failure of the fatigue specimens was the same in all cases, occurring at the holes of the outer rows of screws, as shown on the photograph of a typical failure, Plate 13. Contrary to expectations, failure did not initiate at the countersunk side of the test sheet which is the location of the highest stress concentration and the smallest area. Rather, failure started at the holes at the inner or non-countersunk side of the test sheet, as shown on Plate 14, because of the fretting action due to the slight relative periodic motion between the 1/8" test sheet and the 3/8" back-up plate. The fretting action resulted in pitting and roughened inner faying surfaces in the area immediately adjacent to the holes, thus increasing the stress concentration factor there to a greater value than on the countersunk side of the holes.

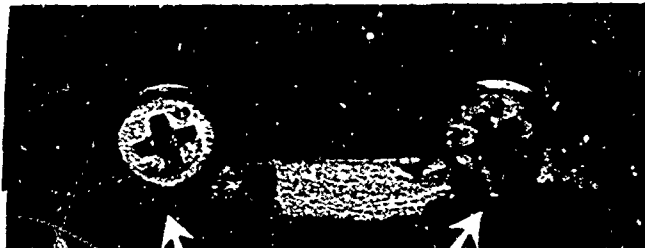
PLATE 14

Failure Initiation

INITIATION OF FATIGUE FAILURES
